Manhole Inspection Summary

Manhole # S21K1_024MH

Location Address: **3102 SAVOY ST**

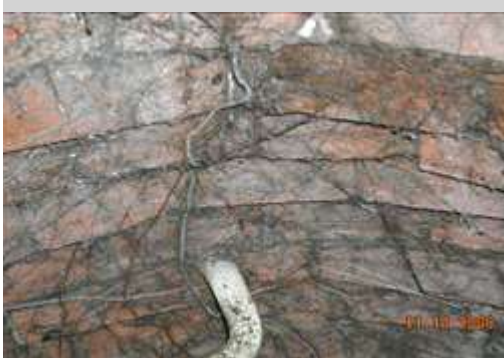
Defect 5

Condition: ☐ Sound ☐ Cracked ☒ **Root Intrusion** ☐ Loose Brick ☐ Deteriorated

ROOT INTRUSION @ CORBEL WALL

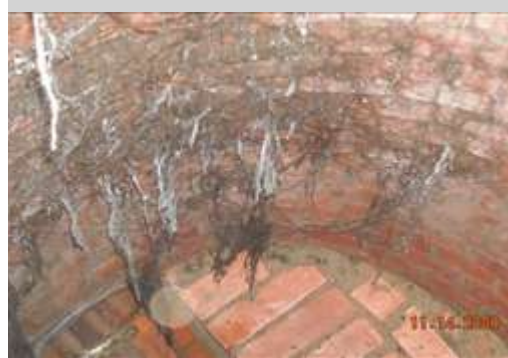
Defect 4

Condition: ☐ Sound ☐ Cracked ☒ **Root Intrusion** ☐ Loose Brick ☐ Deteriorated

ROOT INTRUSION @ BARREL WALL

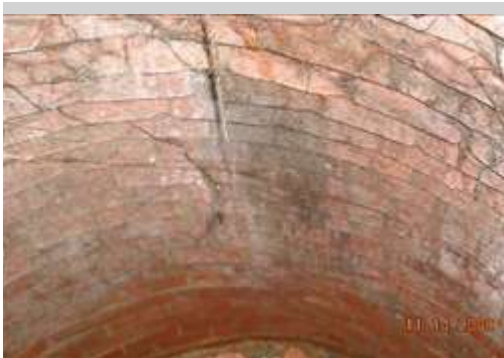
Defect 3

Infiltration: ☐ None ☐ Joint ☐ Cracks ☐ Mortar ☐ Roots ☒ **Wall**

INFILTRATION @ CORBEL WALL

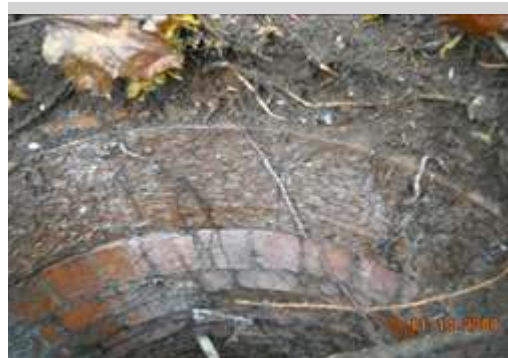
Defect 2

Frame Offset: **0** (in.) Condition: ☐ Sound ☐ Cracked ☒ **Leaks**

FRAME LEAKS/ROOTS INTRUSION @
COVER/FRAME JOINT

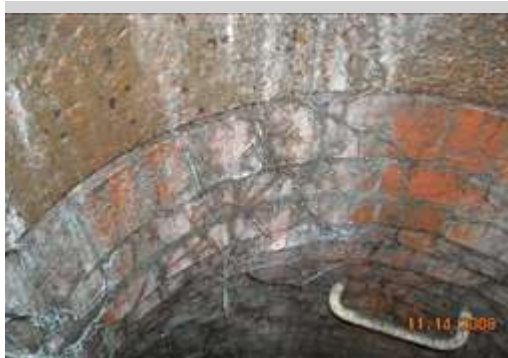
Defect 1

Condition: ☐ Sound ☐ Cracked ☒ **Root Intrusion** ☐ Loose Brick ☐ Deteriorated

ROOT INTRUSION @ CHIMNEY/FRAME
JOINT

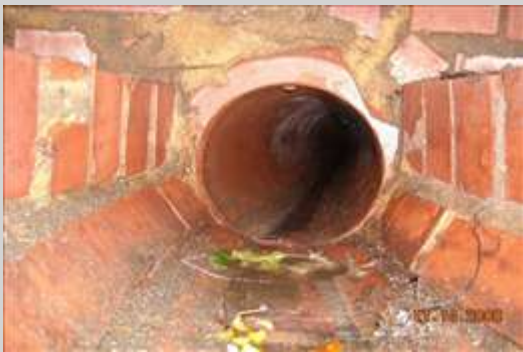
12 O'Clock Outflow

8 in. Circular Gravity Sewer
Pipe Out @ 12 O'Clock

Pipe Height: **8.4** (in.) Rod and Bar (Angled)
Pipe Material: **Clay** ☐ Pipe Lined
Invert Depth: **8.25** (ft.) Flow Characteristics: **Slow**
Deposits: ☒ None ☐ Mud ☐ Sludge ☐ Debris ☐ Grease
Silt Depth: **0** (in.) Deposits Extent:
Infiltration: **None** Pipe Seal Cond: **Sound**

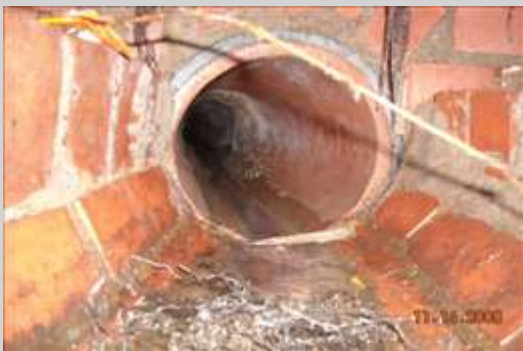
5 O'Clock Inflow

8 in. Circular Gravity Sewer
Pipe In @ 5 O'Clock

Pipe Height: **8.4** (in.) Rod and Bar (Angled)
Pipe Material: **Clay** ☐ Pipe Lined
Invert Depth: **8.04** (ft.) Flow Characteristics: **Slow**
Deposits: ☒ None ☐ Mud ☐ Sludge ☐ Debris ☐ Grease
Silt Depth: **0** (in.) Deposits Extent:
Infiltration: **None** Pipe Seal Cond: **Sound**
